Master Plan Appendices

Seward Marine Terminal Expansion Planning

Seward Marine Terminal Passenger Dock Condition Assessment

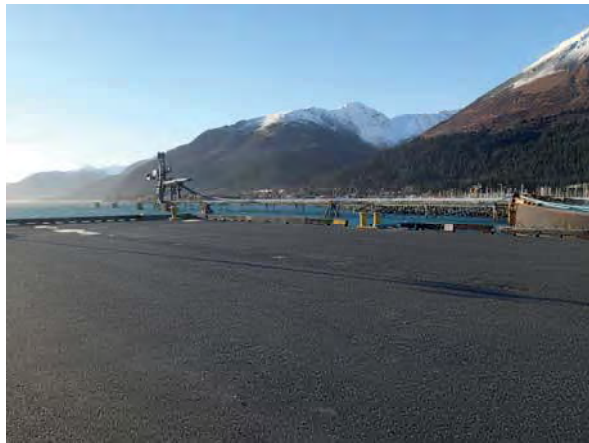
Deck with Asphalt Overlay

The precast concrete deck was found to be in satisfactory condition with little damage.

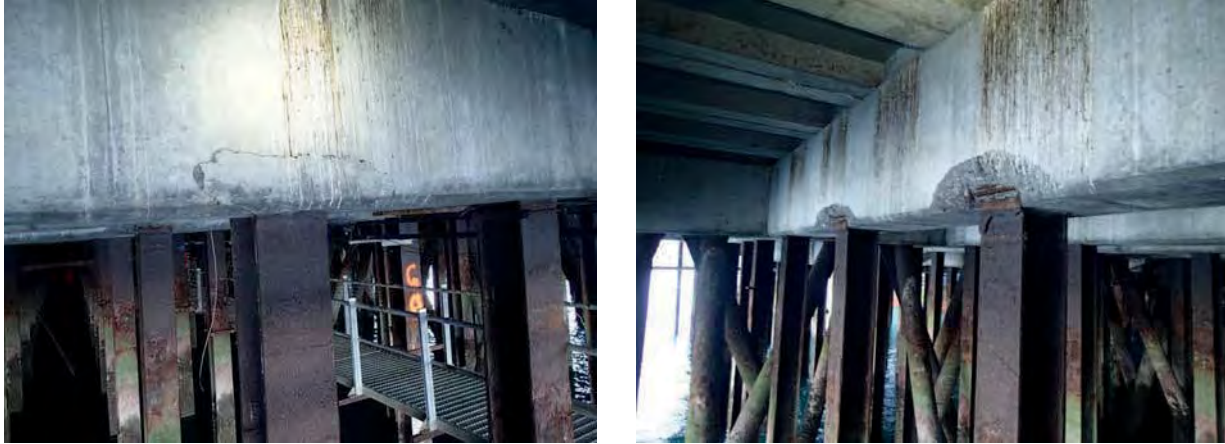
Cast-In-Place Concrete Pile Cap with Local Spalling at Pile Embed.

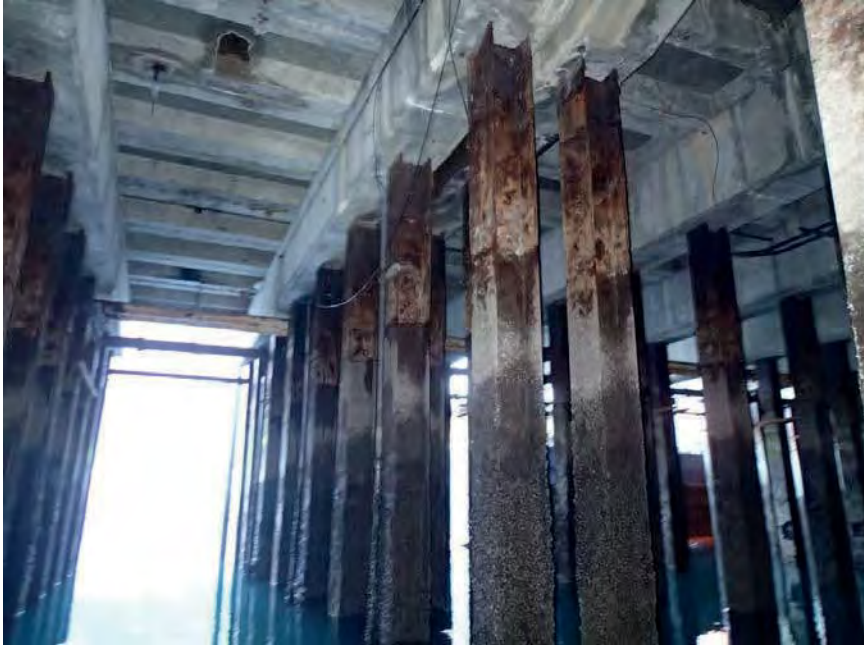
The H pilings on this dock are the primary structural members to resist vertical loads. These include the dead load (self-weight) of the structure and any live loads. The original design for the dock included provisions to run rail cars onto the deck and for a gantry crane. Because these functions are no longer used, the live loads are less than the original design condition. Piling with significant section loss may require structural repairs in order to regain vertical load capacity. This could be done with repair clamps or with a reinforced jacket and grout system. Corrosion in this zone can be mitigated by coatings or by a pile encasement system.

Typical H Piling. Note corrosion in the splash zone

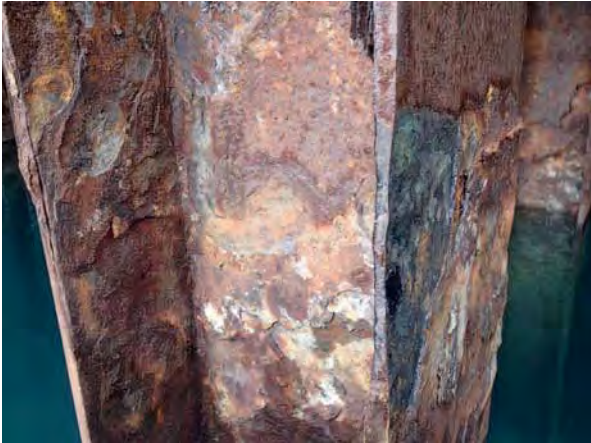
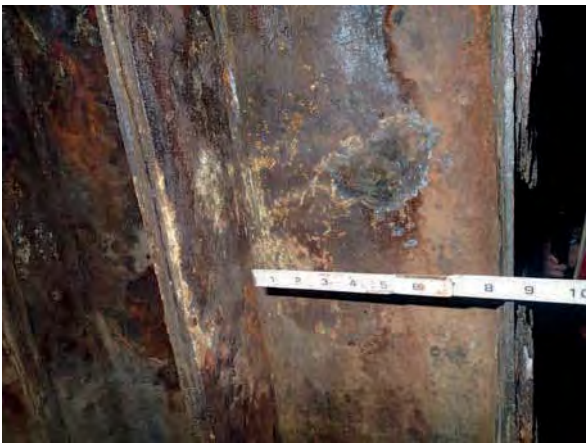
Corrosion of H Piling in the Splash Zone

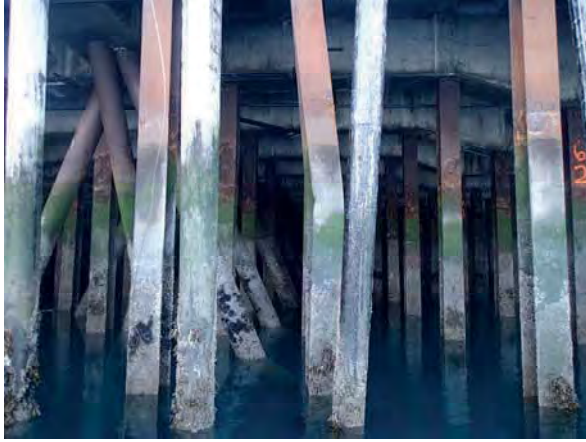
Impact Damage to Piling at Bent 63 Row 9

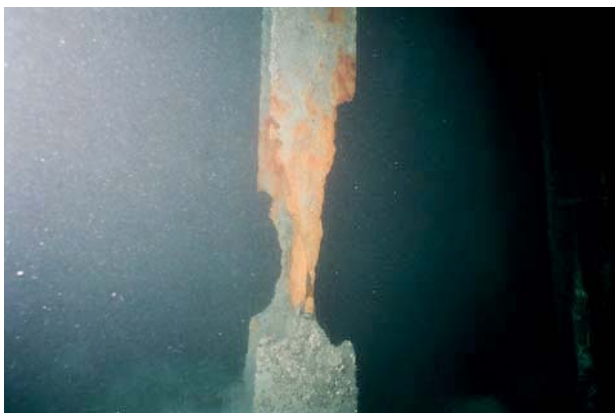
Underwater Photo Bent 10 Pile 11

Similar to the above water portion of the H-piling, in general the piling close to the beach seem to have more corrosion than the piling further offshore. This may be due to agitation and spray from the waves breaking in the shallow water.

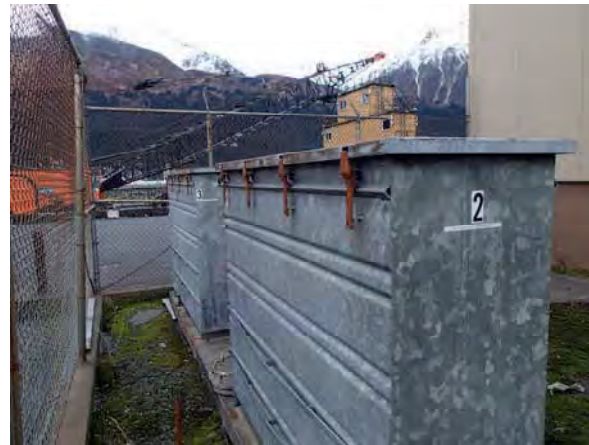
Abandoned Oil Cooled Rectifiers

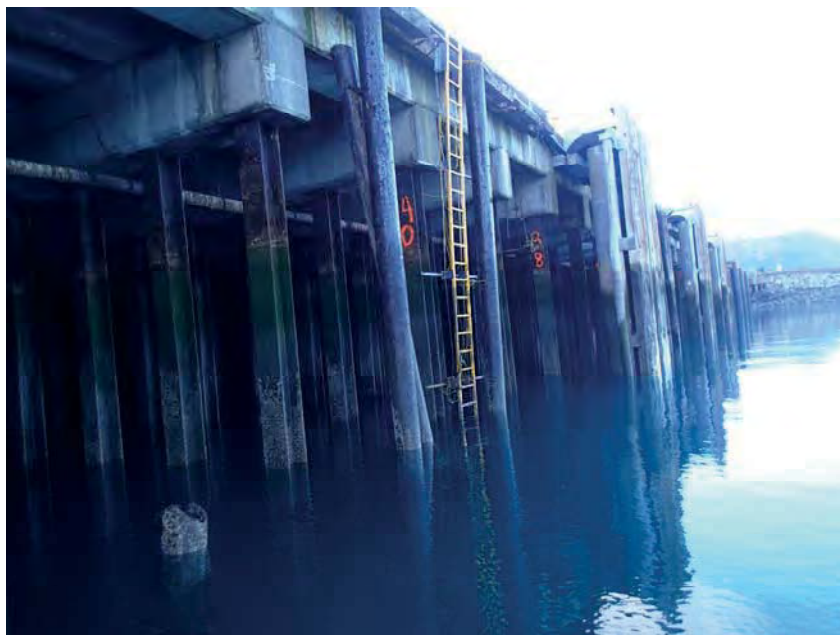
The ladders were in poor condition. There are synthetic ladders at several locations around the dock. These seem to be industrial portable building trades extension units and not specifically designed for use on a dock. The lower attachment braces for many of these have become detached and the ladders are bowed in places. Fabricated galvanized steel ladders are more typically found on docks.

Typical ladder. Note supports detached from pile on left.

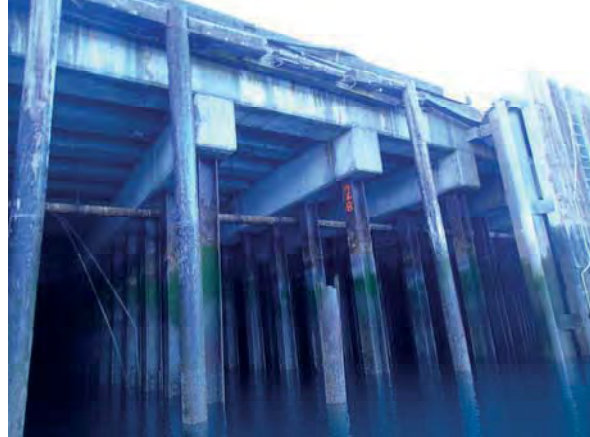
Missing and Broken Fender Piles

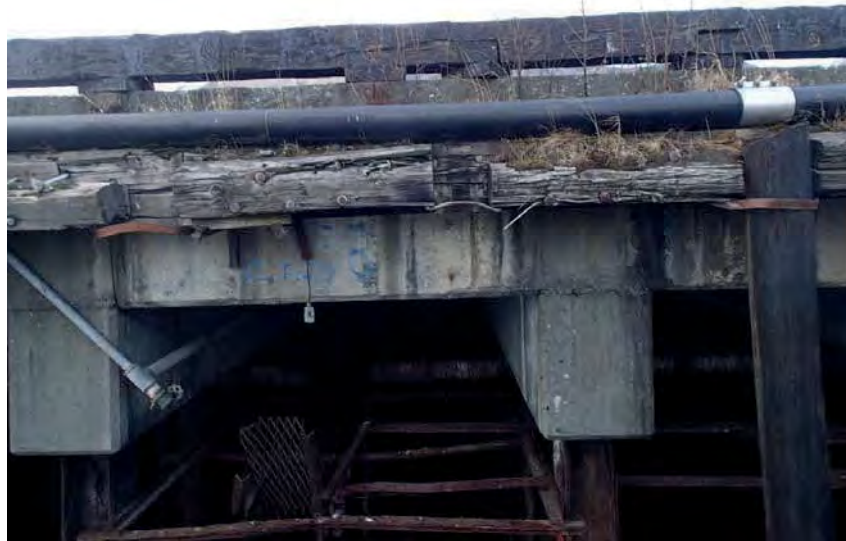
Timber Wale

The timber wale was in serious condition. The majority of the timber wale system should be replaced. The system includes about 1650 linear feet of continuous horizontal timber wale and shorter timber chocks between timber fender piling. The timbers are deteriorated and detached in some places. There is grass and small bushes growing on them in places. There are utilities including water and electrical lines running down the dock on top of the wale. Replacement of the wale and chock system needs to consider these lines.

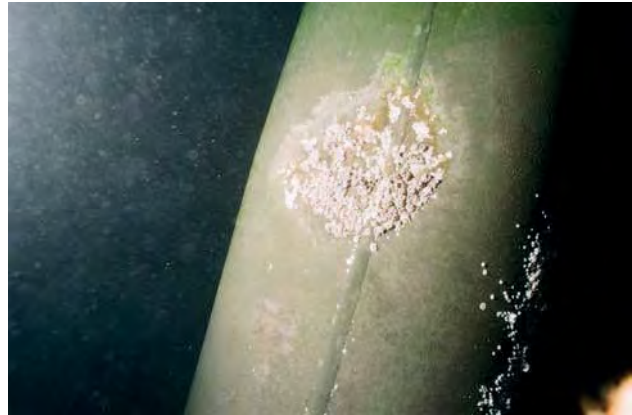
Small Dent in Dolphin Pile
