Master Plan Appendices

Seward Marine Terminal Expansion Planning

Seward Marine Terminal Passenger Dock Condition Assessment

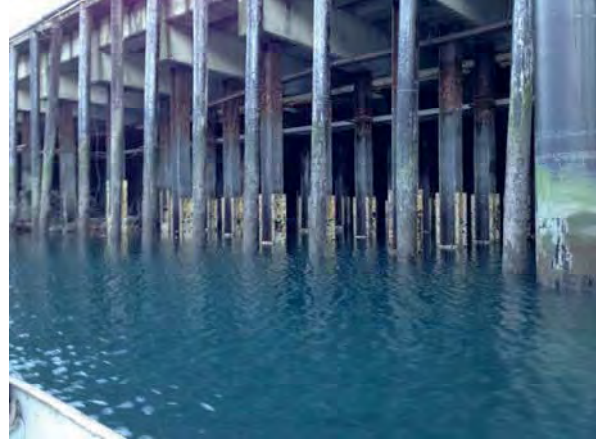
Pile Repair Clamps

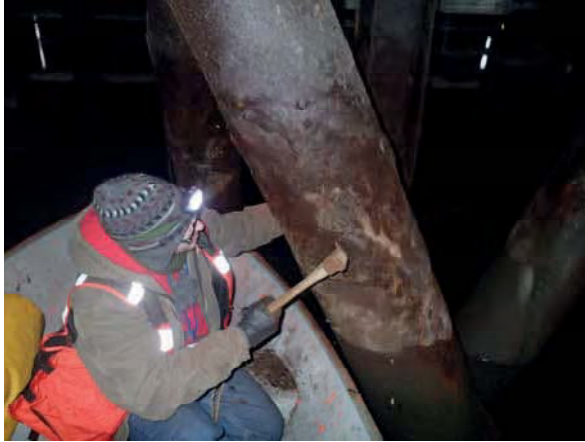
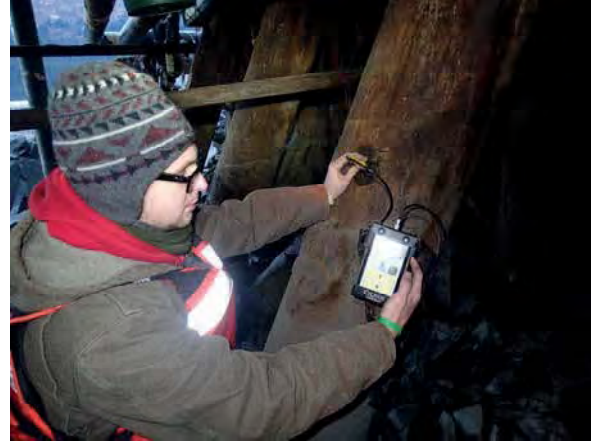
For this dock, the pipe piling form the primary structural members to resist lateral loads such as seismic. These piling are quite stiff compared to the plumb piling and therefore collect the majority of the lateral loads. The loss of section for the pipe piling is directly related to the loss of capacity to withstand a seismic event. Pipe piling with significant section loss may require structural repairs in order to regain load capacity. This could be done with repair clamps or with a reinforced jacket and grout system.

Cleaning and Inspecting Batter Piles

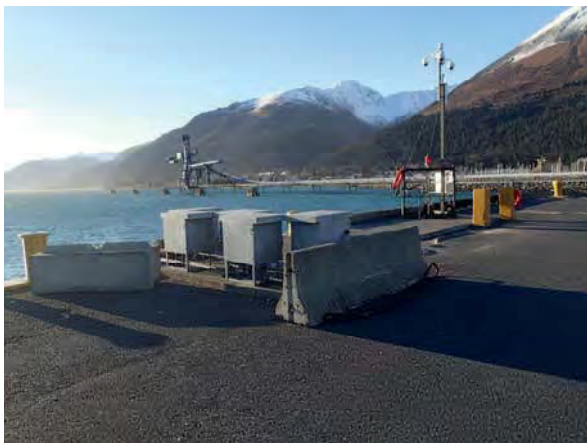
CP Rectifiers South End of Dock

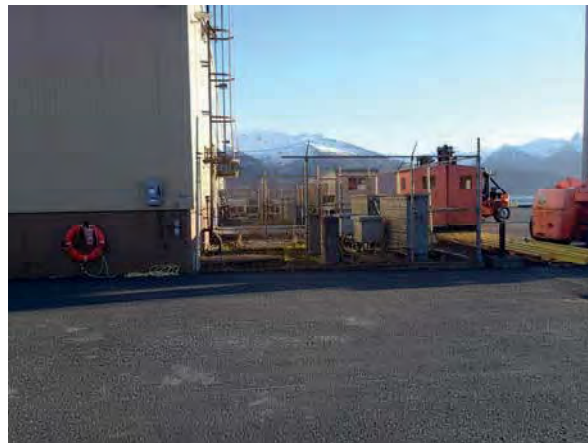
CP Rectifiers Near Building

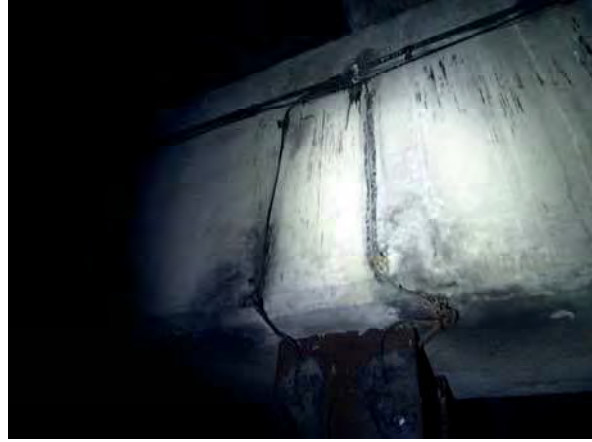
Melted Anode Wires Under Dock

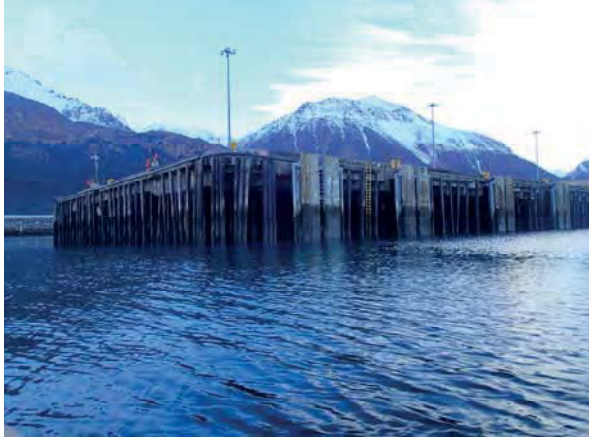
The timber fender piling are in poor condition. There are a number of broken or missing timber fender piling, about 35 total. This results in several gaps in the secondary fender system. These are not the primary fenders but do provide some protection for smaller vessels using the dock.

Fender Piles at End of Dock

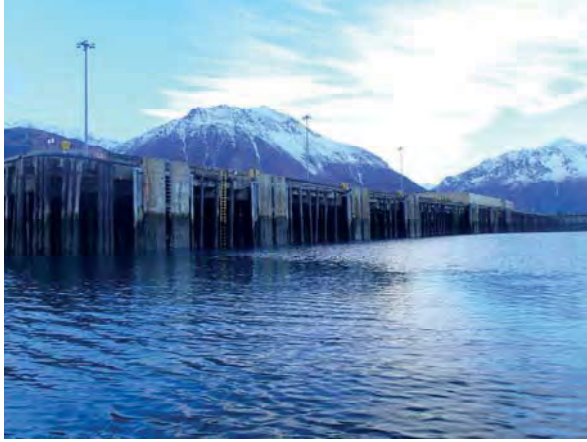
The main fenders are in satisfactory condition. The main fenders are serviceable and no serious issues were noted. Minor wear was noted on the timber facing. No anodes were noted on the pin piles. It is recommended that sacrificial anodes be attached to the steel framework of the fenders and to the pin piles.

Main Fender at East Side of Dock

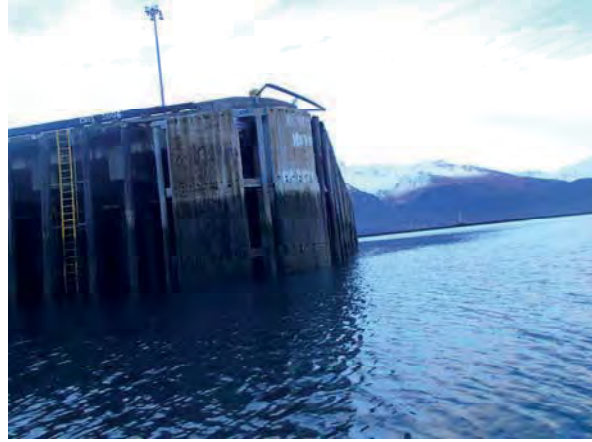
Main Fender SW Corner of Dock

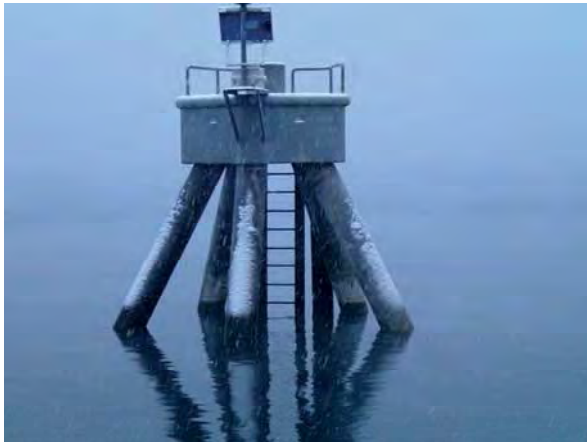
Dolphin

The dolphins are in satisfactory condition. The dolphins are serviceable and no serious issues were noted. A couple of small dents on the piling were noted, possibly from vessel impact. These do not affect the function of the dolphin. There were no anodes on the dolphin piling. The galvanizing was still intact above and below water. It is recommended that sacrificial anodes be attached to the dolphin piling.

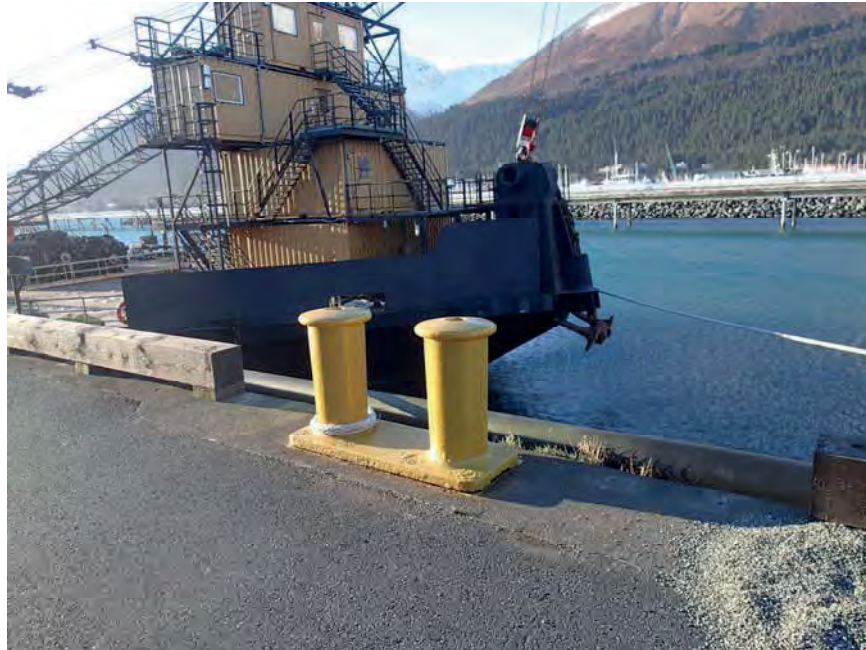
Bollard

The bollards are in satisfactory condition. No damage was noted. The bollards had been recently painted.

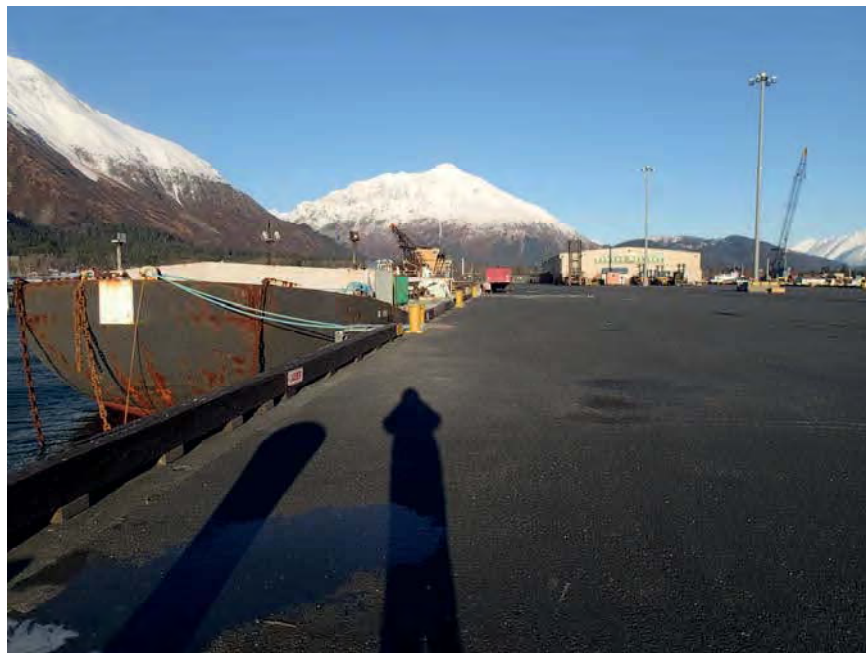
Bullrail

The bullrails are in satisfactory condition. No damage was noted. The timber bullrails have recently been replaced.

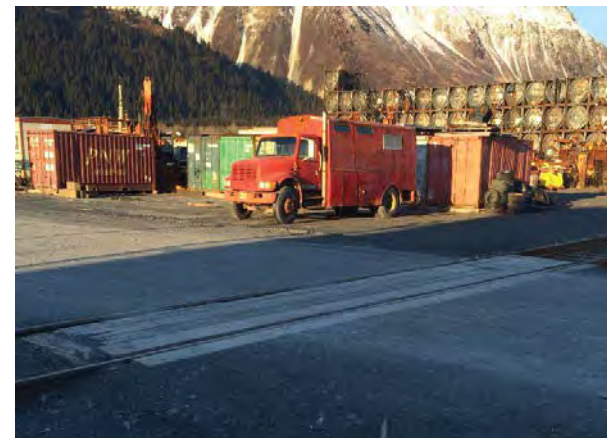
Wood Tie At-Grade Crossing at Port Avenue

- Trespassers in Railyard, illegal access to coastal wetlands for bird-watching.
- Tie condition has deteriorated throughout much of the Railyard and a significant portion of ties are nearing end of life. There is no capital program for tie replacement; only essential maintenance replacement is being conducted.
- At-grade crossing at Port Avenue is in poor condition and creates problems for fork lifts and other equipment.

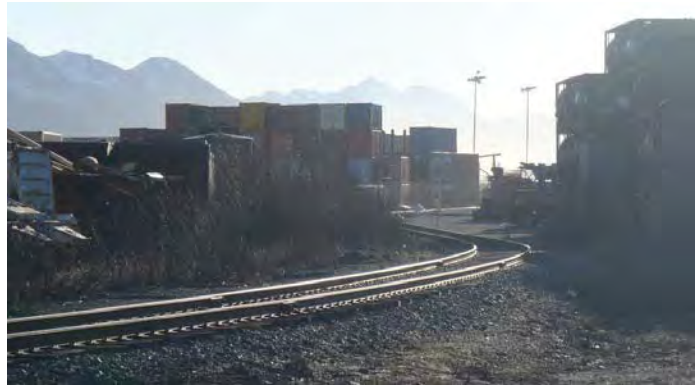
Leased Laydown Area Adjacent to Track No. 1

- The limited length of double track and location of turnouts limits lengths of trains that can be spotted and worked.
- Areas permitted for laydown next to the northern half of the Freight Dock Tracks prevents use of this half of the Freight Dock Tracks for loading/unloading.

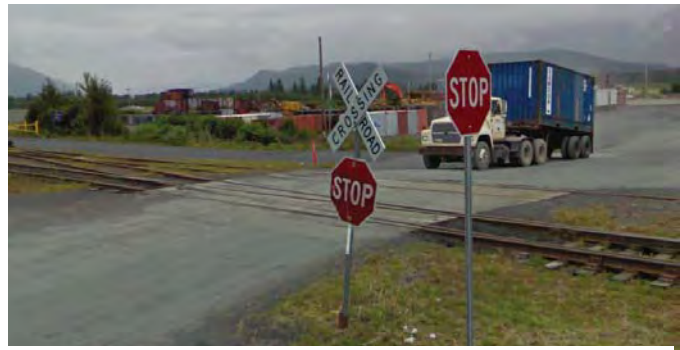
Passenger Dock Tracks, Port Avenue At-Grade Crossing

- At-grade crossing at Port Avenue is in poor condition and has a high grade differential over a short distance. This creates problems for fork lifts, trucks, and other equipment.
